# Wellhead Protection Area Desktop Study

## Wolf Farm Soccer Fields

**Triad Project No.: 03-23-0318**

**April 29, 2023**

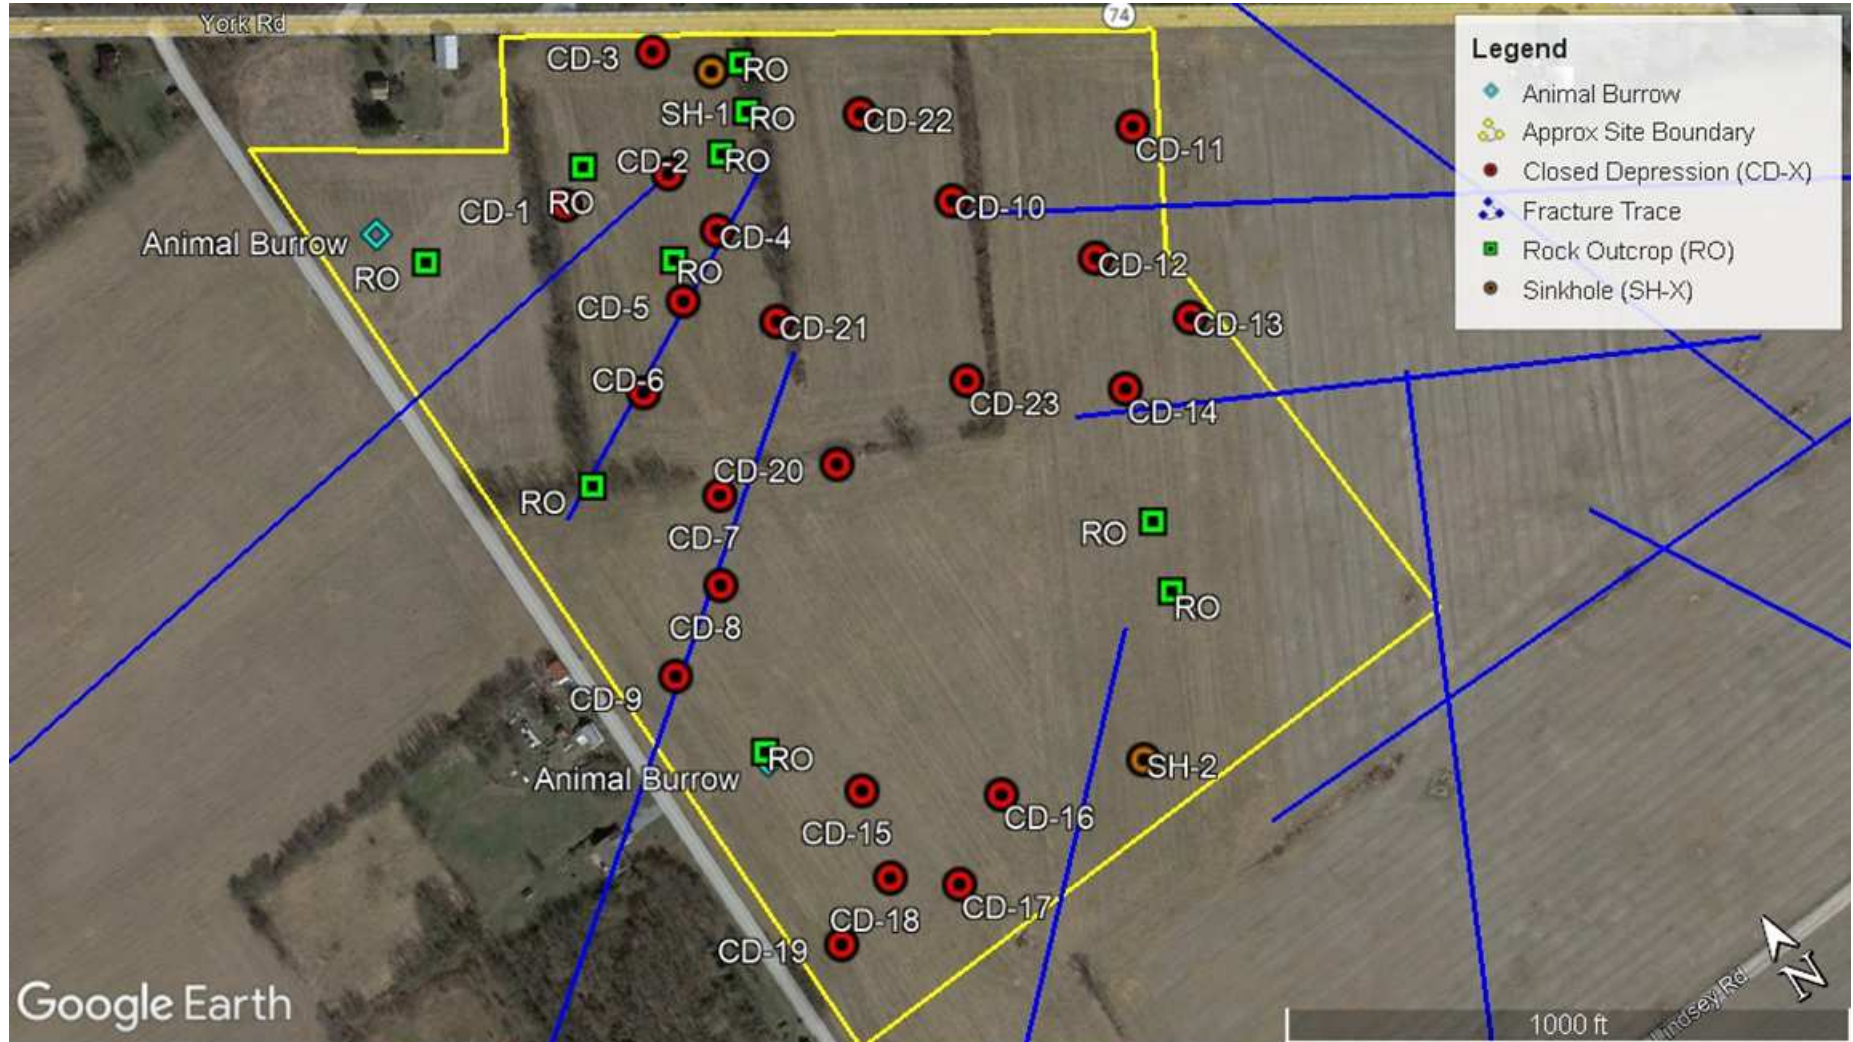
# FIGURE 5

The fracture trace analysis performed for the site identified 12 fracture traces in the site vicinity and approximately six fracture trace intersections within the property boundary as depicted on the Fracture Trace Analysis and Karst Feature plan included as **Figure 5**.

The site visit was conducted on April 29, 2023, by Mr. Nicholas Wolfe, PG (PG004859). The site visit consisted of walking around the site to observe site features and document karst features observed. It is important to note that karst features may exist within inaccessible areas or concealed by vegetation and weren't documented during this site visit. The weather during the site visit was cloudy, with rain and temperatures at approximately 55 degrees Fahrenheit. Mapped karst features are depicted in **Figure 5**.

**Closed Depressions:** Approximately 23 closed depressions were mapped, and field observed. No other closed depressions were observed.

**Open Sinkholes:** Two open sinkholes were observed.

**Based on Figure 5 and Appendix C, there are concerns regarding closed depressions and sinkholes. The site is relatively flat and observed closed depressions were scattered across the site. The identified closed depressions are based on historical mapping and field verification; however, no level was used to verify the closed depressions to confirm that no outlet existed, only visual observations were utilized.** Based on the abundance of closed depressions and sinkholes across the site, any proposed storm water retention facilities with respect to Municipal Ordinance No. 01 of 2001 – updated April 15, 2019 entitled Subdivision & Land Development Ordinance (SALDO), Article 11 entitled Wellhead Protection Design Requirements, Sections 1108 a.(12) which states that “Storm water shall not be directed into a sinkhole or closed depression”, Triad recommends all closed depressions and sinkholes within these areas be remediated via the methods described below. Any alternative methods proposed should be approved by a geotechnical engineer and/or geologist. The intent as stated in Municipal Ordinance No. 01 of 2001 – updated April 15, 2019 entitled Subdivision & Land Development Ordinance (SALDO), Article 11 entitled Wellhead Protection Design Requirements, Sections 1106, “is to minimize impervious surfaces and reduce storm water runoff; to provide storm water management practices that maintain groundwater recharge; and, protect and enhance surface and groundwater quality from the impacts of development on storm water quality utilizing Best Management Practices.” It is understood that the site has very low loading ratios and that storm water management runoff will be dispersed across the site to avoid specific concentrations.
