# Wellhead Protection Area Desktop Study

## Wolf Farm Soccer Fields

**Triad Project No.: 03-23-0318**

**April 29, 2023**

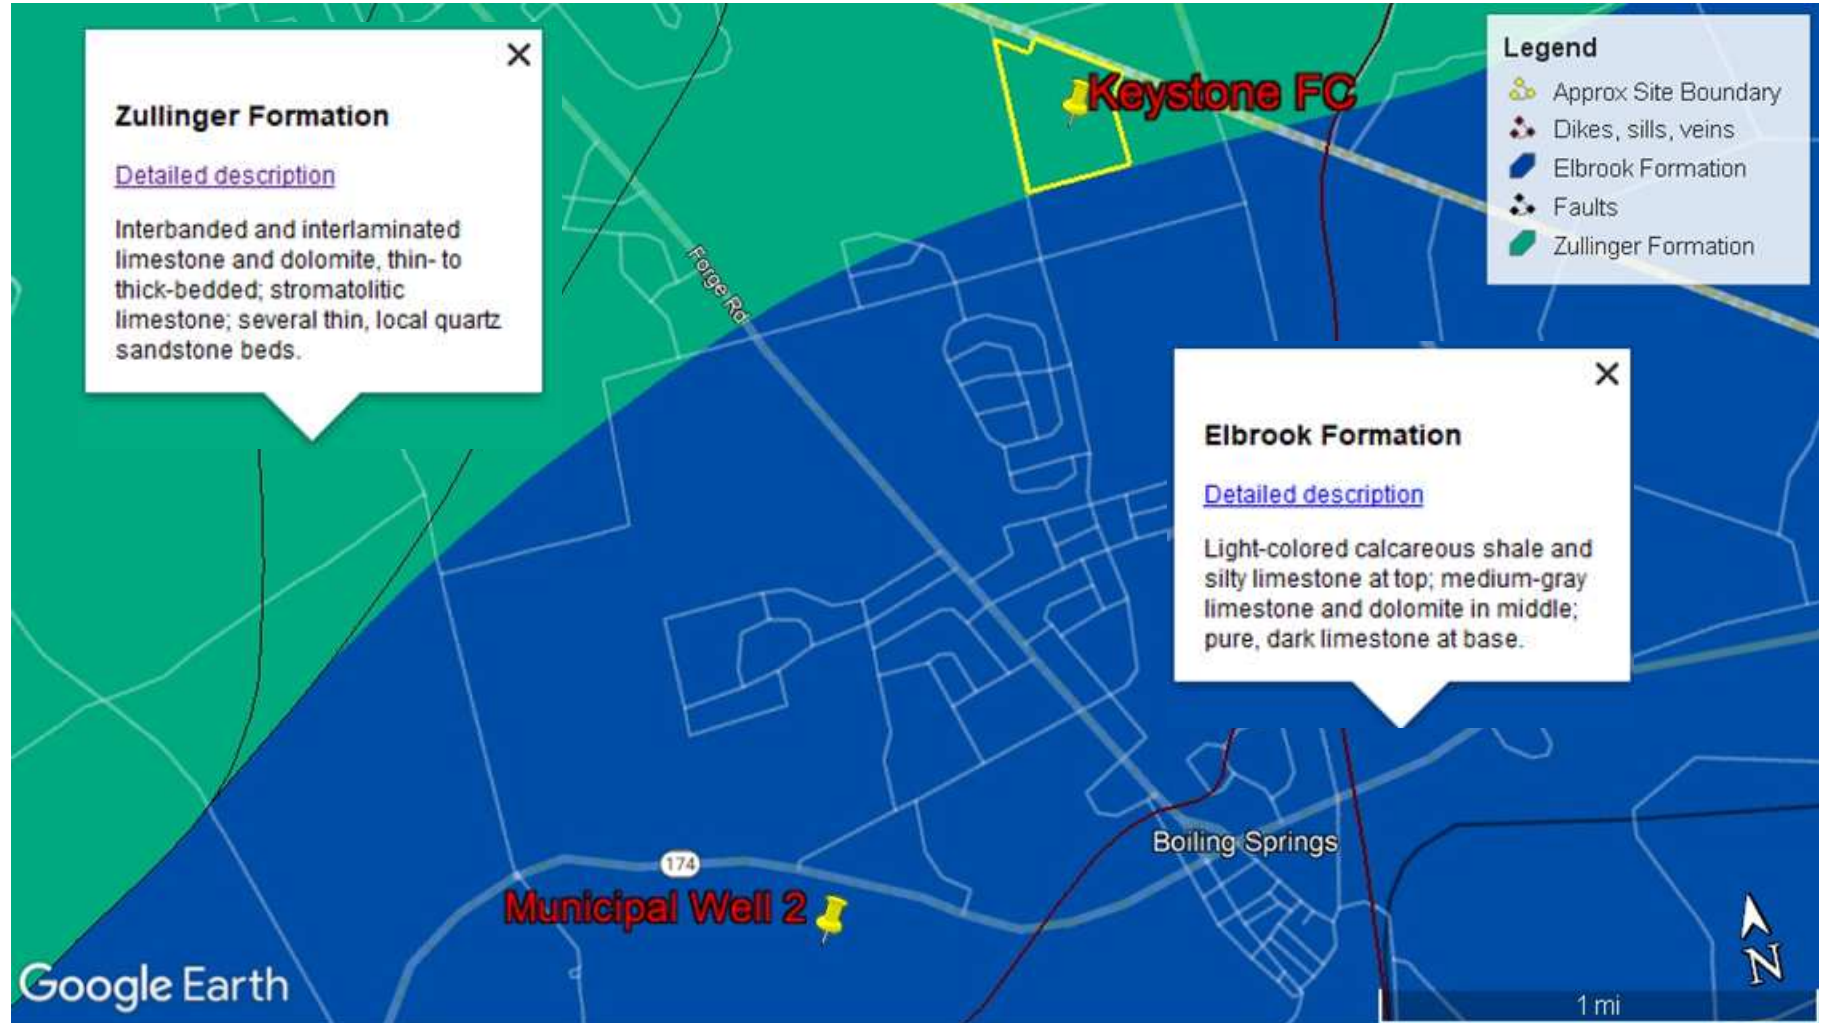
# FIGURE 5

The fracture trace analysis performed for the site identified 12 fracture traces in the site vicinity and approximately six fracture trace intersections within the property boundary as depicted on the Fracture Trace Analysis and Karst Feature plan included as **Figure 5**.

**Closed Depressions:** Approximately 23 closed depressions were mapped, and field observed. No other closed depressions were observed.

**Open Sinkholes:** Two open sinkholes were observed.

**Based on Figure 5 and Appendix C, there are concerns regarding closed depressions and sinkholes. The site is relatively flat and observed closed depressions were scattered across the site. The identified closed depressions are based on historical mapping and field verification; however, no level was used to verify the closed depressions to confirm that no outlet existed, only visual observations were utilized.** Based on the abundance of closed depressions and sinkholes across the site, any proposed storm water retention facilities with respect to Municipal Ordinance No. 01 of 2001 – updated April 15, 2019 entitled Subdivision & Land Development Ordinance (SALDO), Article 11 entitled Wellhead Protection Design Requirements, Sections 1108 a.(12) which states that “Storm water shall not be directed into a sinkhole or closed depression”, Triad recommends all closed depressions and sinkholes within these areas be remediated via the methods described below. Any alternative methods proposed should be approved by a geotechnical engineer and/or geologist. The intent as stated in Municipal Ordinance No. 01 of 2001 – updated April 15, 2019 entitled Subdivision & Land Development Ordinance (SALDO), Article 11 entitled Wellhead Protection Design Requirements, Sections 1106, “is to minimize impervious surfaces and reduce storm water runoff; to provide storm water management practices that maintain groundwater recharge; and, protect and enhance surface and groundwater quality from the impacts of development on storm water quality utilizing Best Management Practices.” It is understood that the site has very low loading ratios and that storm water management runoff will be dispersed across the site to avoid specific concentrations.
